2010-10-12 Bell Helicopter Textron Canada: Amendment 39-16291. Docket No. FAA-2008-0071; Directorate Identifier 2006-SW-27-AD. Supersedes AD 2005-04-09, Amendment 39-13981, Docket No. FAA-2005- 20107.

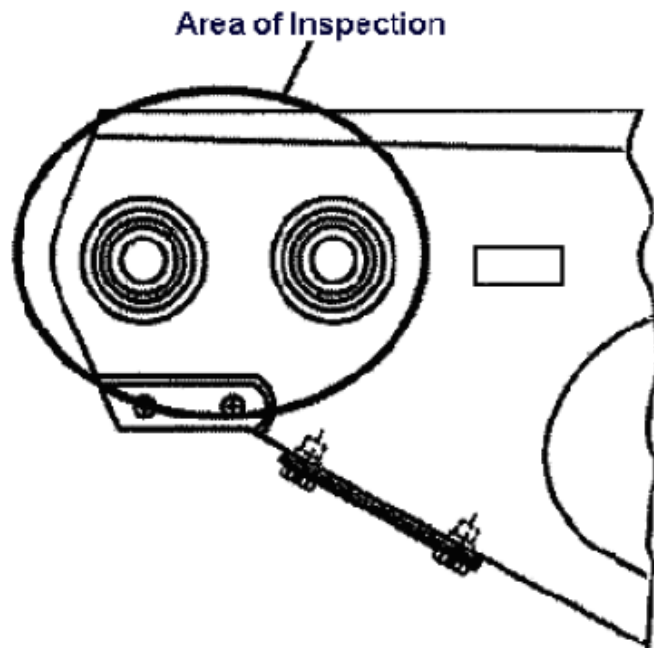
Figure 1
Blade Inspection Area

To detect a crack in a blade, and to prevent loss of the blade and subsequent loss of control of the helicopter, accomplish the following:

(a) Within 3 hours time-in-service (TIS), unless accomplished previously, and thereafter at intervals not to exceed 3 hours TIS, clean and visually check both sides of each blade for a crack in the paint in the areas shown in Figure 1 of this AD. An owner/operator (pilot), holding at least a private pilot certificate, may perform this visual check and must enter compliance with this paragraph into the helicopter maintenance records by following 14 CFR 43.11 and 91.417(a)(2)(v).

(c) Within the next 50 hours TIS, unless accomplished previously, and thereafter at intervals not to exceed 50 hours TIS, clean the blade by wiping down both surfaces of each blade in the inspection area depicted in Figure 1 of this AD using aliphatic naphtha (C-305) or detergent (C-318) or an equivalent. Using a 10X or higher power magnifying glass, visually inspect both sides of the blade in the areas depicted in Figure 1 of this AD.

(1) If a crack is found, even if only in the paint, before further flight, remove the blade from the helicopter and proceed with the following:

(2) Remove the paint on the blade down to the bare metal in the area of the suspected crack by using plastic media blasting (PMB) or a nylon web abrasive pad. Abrade the blade surface in a span-wise direction only.

(3) Using a 10X or higher power magnifying glass, inspect the blade for a crack.

(i) If a crack is found, replace the blade with an airworthy blade before further flight.

(ii) If no crack is found in the blade surface, refinish the blade by applying one coat of epoxy polyamide primer, MIL-P-23377 or MIL-P- 85582, so that the primer overlaps the existing coats just beyond the abraded area. Let the area dry for 30 minutes to 1 hour. Then, apply one sealer coat of polyurethane, MILC85285 TYI CL2, color number 27925 (semi-gloss white). Reinstall the blade. Note 4: BHT-ALL-SPM, chapter 4, contains guidance on painting the blade.
