**2011-18-52 AGUSTA S.p.A (AGUSTA):** Directorate Identifier 2011-SW-055-AD.

Applicability: Agusta Model AB139 and AW139 helicopters, with tail rotor (T/R) blades, part number P/N 3G6410A00131 or P/N 4G6410A00131, certificated in any category.

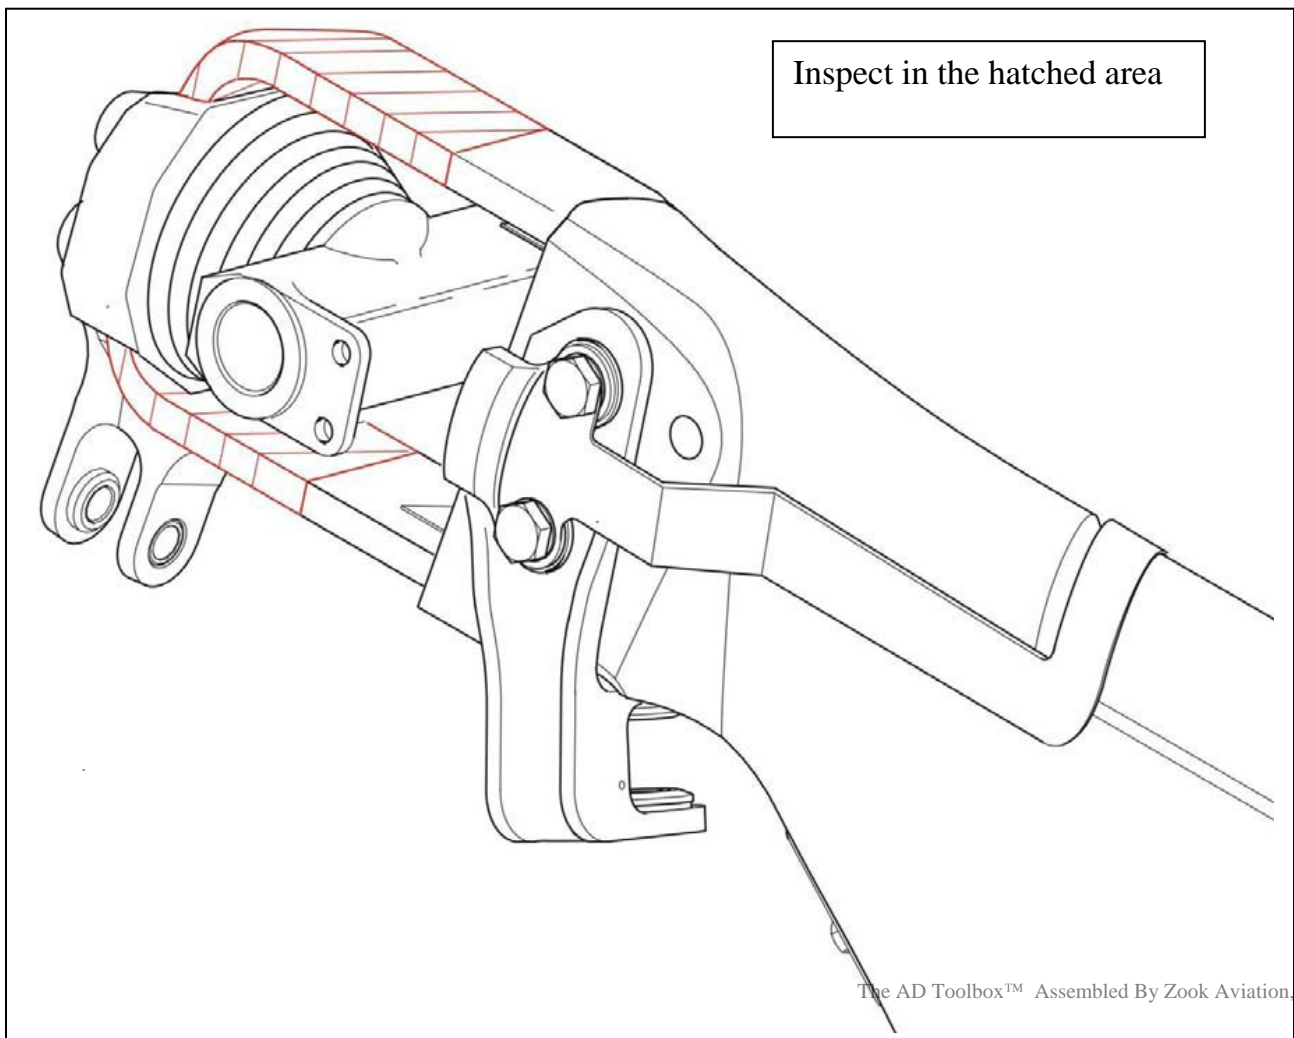
To detect and prevent a crack in a T/R blade, which could lead to failure of a T/R blade, and subsequent loss of control of the helicopter, accomplish the following:

(c) Within 25 hours TIS, and thereafter at intervals not to exceed 25 hours TIS, visually inspect the T/R blade for a crack or damage that exceeds the limits of the applicable maintenance manual. Inspect in the area depicted in the following figure using a mirror, magnifying glass (5X or greater), and light source; or borescope.

(d) If there is a crack, or if there is damage that exceeds the limits of the applicable maintenance manual, before further flight, replace the T/R blade with an airworthy T/R blade.
