2011-10-09 Cessna Aircraft Company: Amendment 39-16690; Docket No. FAA-2010-1101; Directorate Identifier 2009-CE-013-AD.

(d) Joint Aircraft System Component (JASC)/Air Transport Association (ATA) of America Code 51; Standard Practices Structures.

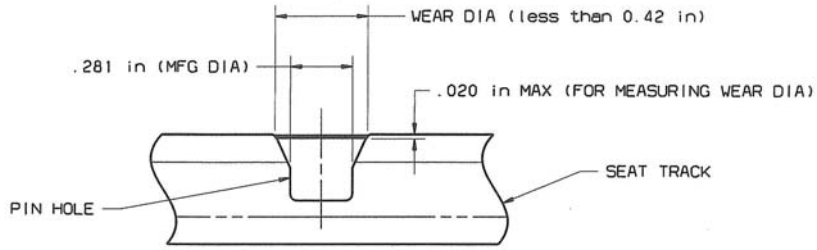
Figure 1. Diameter of seat pin locking engagement hole

(3) Inspect the diameter of each seat locking pin engagement hole in the pilot and copilot seat rails for excessive wear. Due to wear on the rail surface at the hole opening, we allow this measurement 0.020 of an inch below the surface of the rail. You must take this measurement somewhere between the surface of the rail or no more than 0.020 of an inch below the surface of the rail.

(i) If the diameter of any of the holes is 0.42 of an inch or more (see figure 1), before further flight, replace the rail.

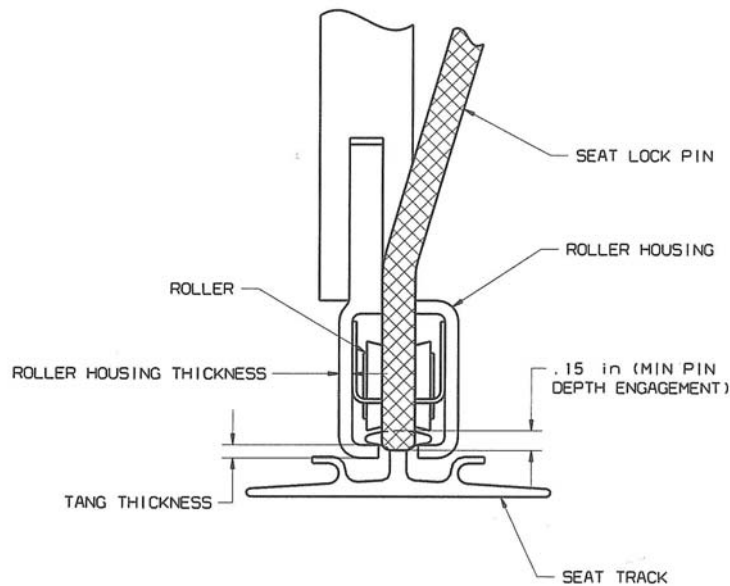
Figure 2. Seat locking pin depth engagement

(10) Lift up the forward edge of each seat to eliminate vertical play of the seat locking pin in the engagement hole, and from this position, inspect the depth of engagement of each seat locking pin (see figure 2). If the rail is worn, this depth is measured from the worn surface, not the manufactured surface.

(i) If engagement of any of the seat locking pins measures less than 0.15 of an inch, before further flight, replace or repair any seat components necessary to achieve a seat pin engagement of a minimum of 0.15 of an inch.

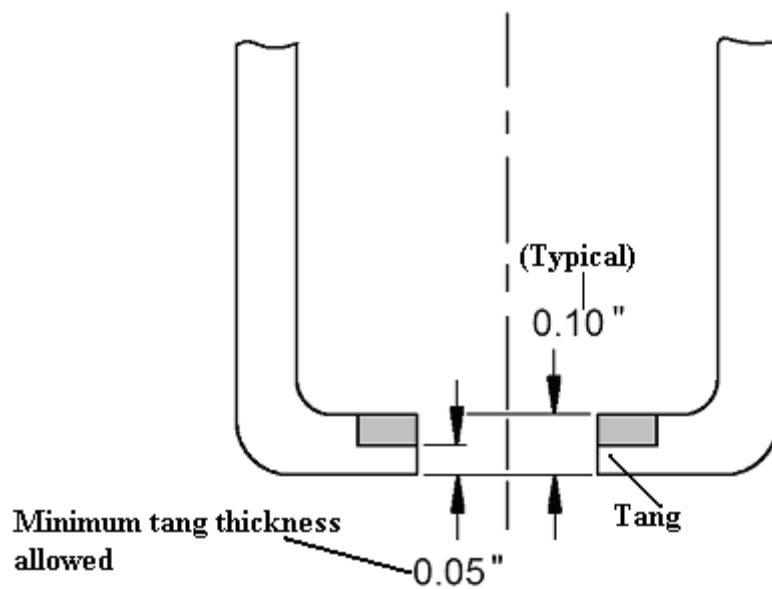
Figure 3. Closeup of seat roller housing and tang thickness

(5) Inspect the thickness of the tang (see figure 2 and figure 3). Due to wear of the tang chafing against the seat rail, measure the tang thickness where the tang inner edges contact the seat rail.

(i) If the tang thickness measures less than 0.05 of an inch, before further flight replace the roller housing.

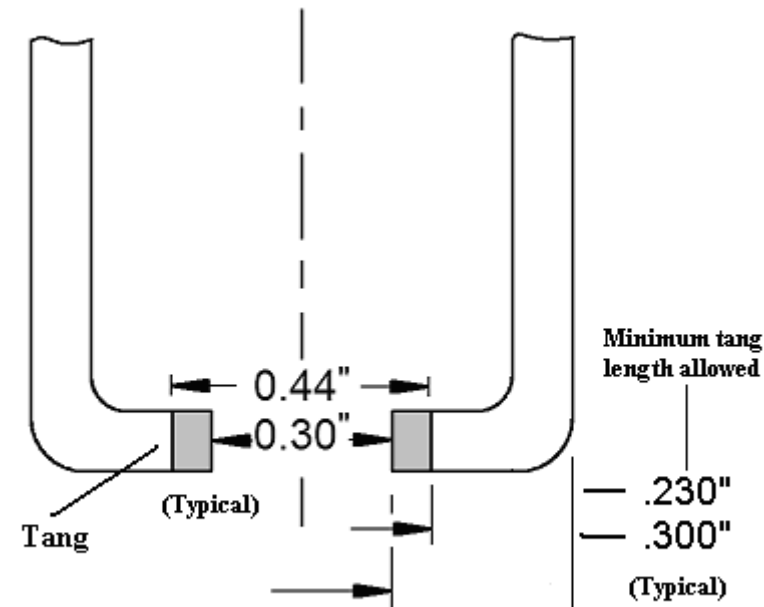
(6) Due to wear or deformation of the tangs, inspect the tang length from the inner edge of the tang to the outer edge (the bend area) of the roller housing (see figure 4).

(i) The minimum measurement allowed for the remaining tang length is 0.230 inches remaining on either of the tangs, from the inner edge of the tang to the outer edge (the bend area) of the roller housing. If the measurement is less than 0.230 inches on either of the tangs, before further flight, replace the roller housing.

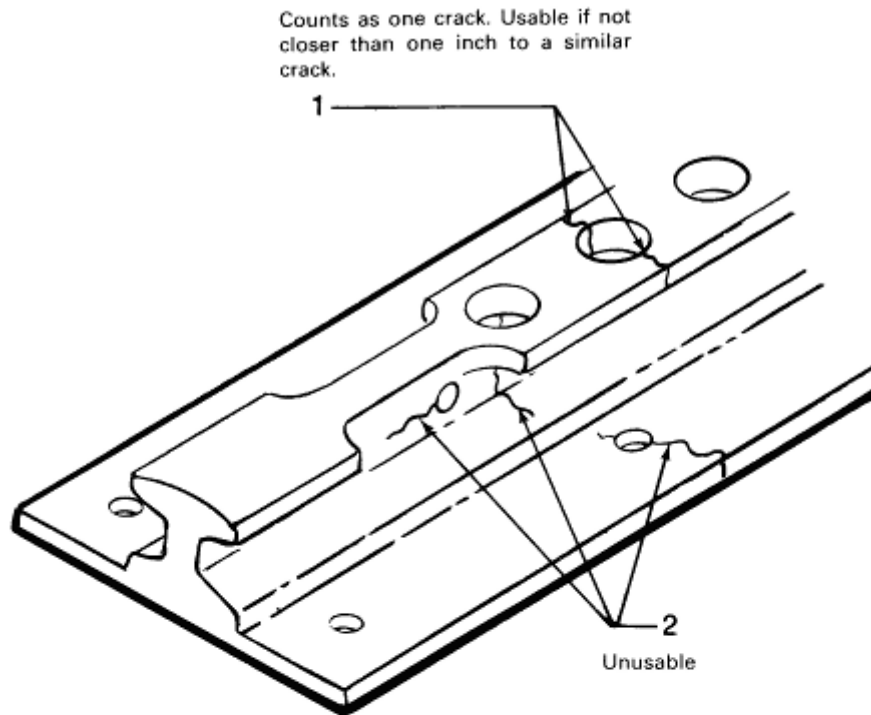
Figure 5. Seat rail

(8) Visually inspect the seat rails for cracks.

- (1) Any portion of web or lower flange is cracked (index 2).
- (2) Any crack in crown of rail is in any direction other than right angle to length of rail.
- (3) Number of cracks on any one rail exceeds four, or any two cracks (index 1) are closer than one inch.

(i) If there are seat rail cracks that exceed the crack criteria in figure 5, before further flight, replace the seat rail.

REPLACE SEAT RAIL WHEN:
